Indoor radon survey - preliminary results from Sološnica village, Slovakia

Iveta Smetanová¹ - Andrej Mojzeš² - František Marko² - Kamil Fekete¹

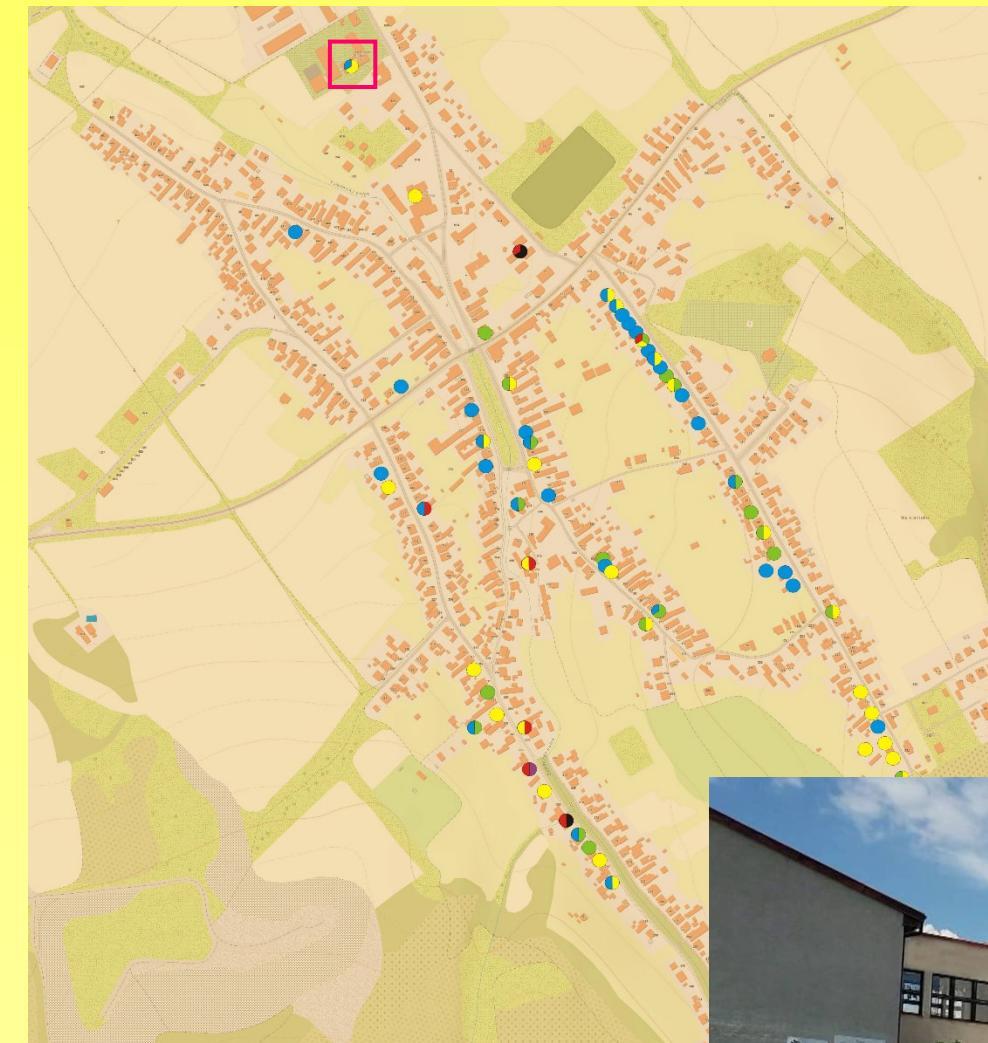
Primary school – three monitored classrooms on the groundfloor

- built in 1942 from brick
- reconstructed in 1992, another part of building was added, made of aerated concrete
- new windows, no thermal insulation
- two monitored classroom in old part (cellar/no cellar) and one in new part (no cellar) of the building
- low indoor radon (max 130 Bq/m³) (one detector was lost)

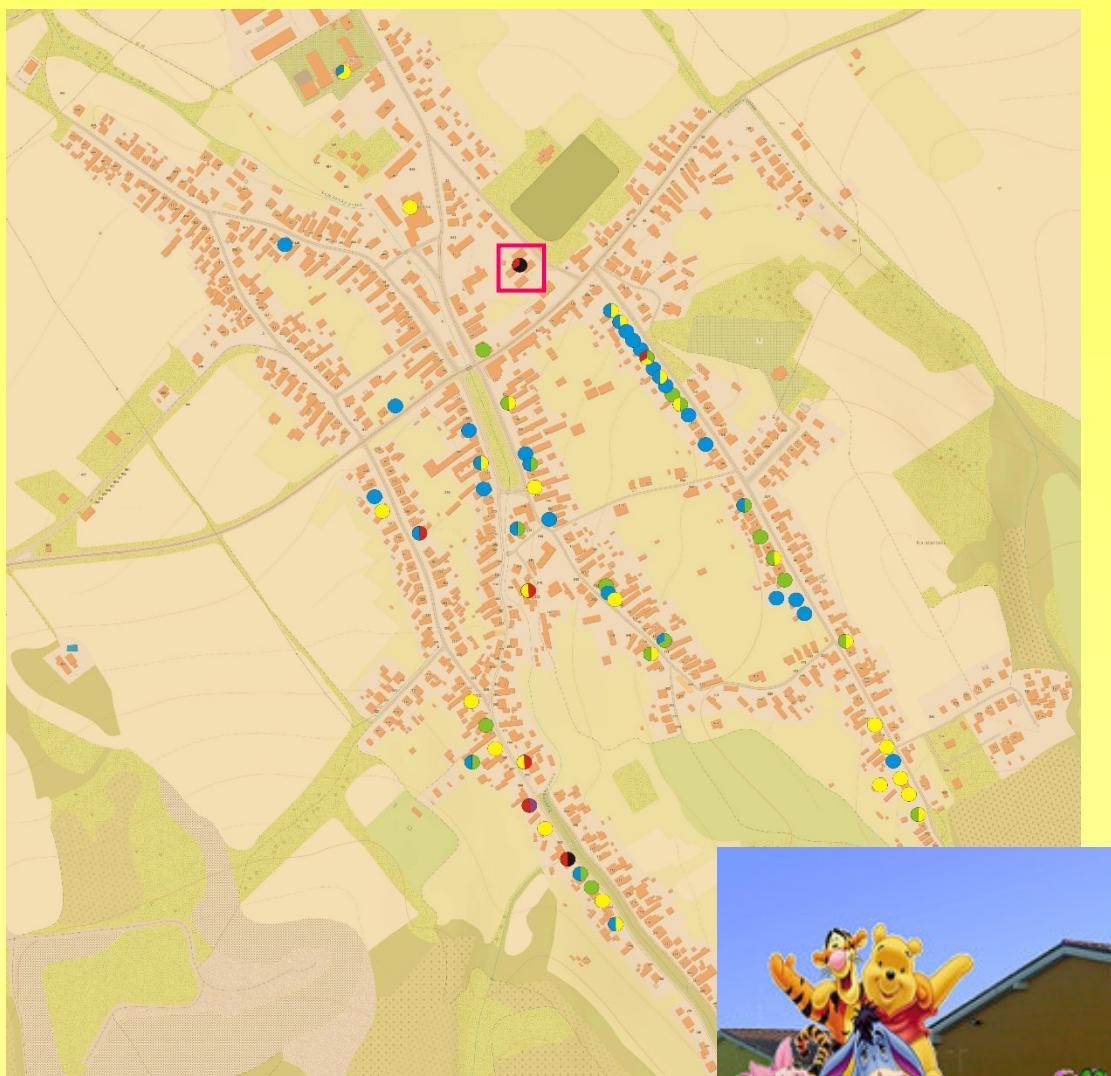
Kindergarten \rightarrow increased indoor radon activities in all 3 monitored classrooms

Frogs: 315 ± 55 Bq/m³

Butterflies: 365 ± 35 Bq/m³

Owls: 250 ± 50 Bq/m³

- single storey building
- made of brick, no cellar
- built in 1972 (79), reconstructed in 2008
- thermal insulation, new windows
- intensive ventilation according to the questionnaire
- teachers were recommended to increase the ventilation of classrooms
