Indoor radon survey - preliminary results from Sološnica village, Slovakia

Iveta Smetanová¹ - Andrej Mojzeš² - František Marko² - Kamil Fekete¹

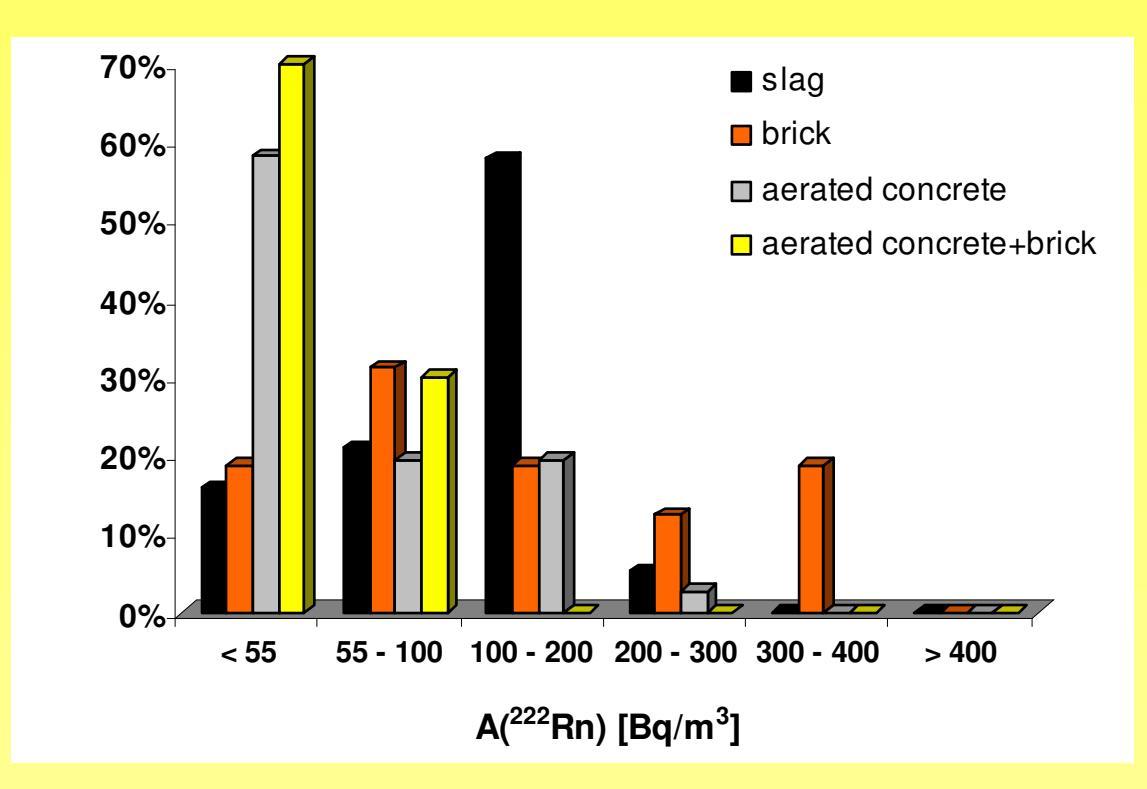
The comparison of indoor radon concentration

- the lowest indoor radon buildings made of aerated concrete and aerated concrete + bricks
- houses made of slag blocks has higher indoor radon
- several rooms in buildings made of bricks have indoor radon levels exceeding 300 Bq/m³
- ▶ the highest indoor radon (415 Bq/m³) was found in a house made of slag blocks + bricks

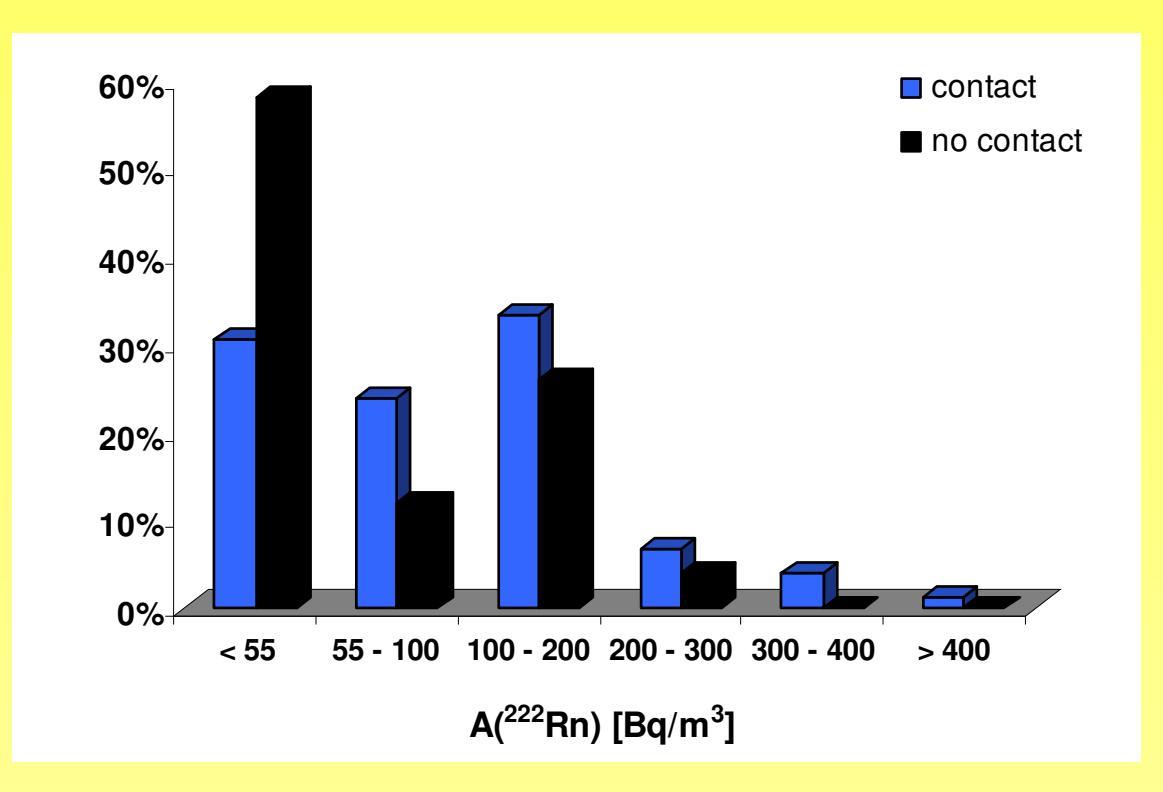
The comparison of indoor radon concentration

Iower indoor radon levels in rooms with no direct contact with the subsoil

▶ in 60 % of the rooms situated above the cellar indoor radon levels were lower than the detection limit (55 Bq/m³)

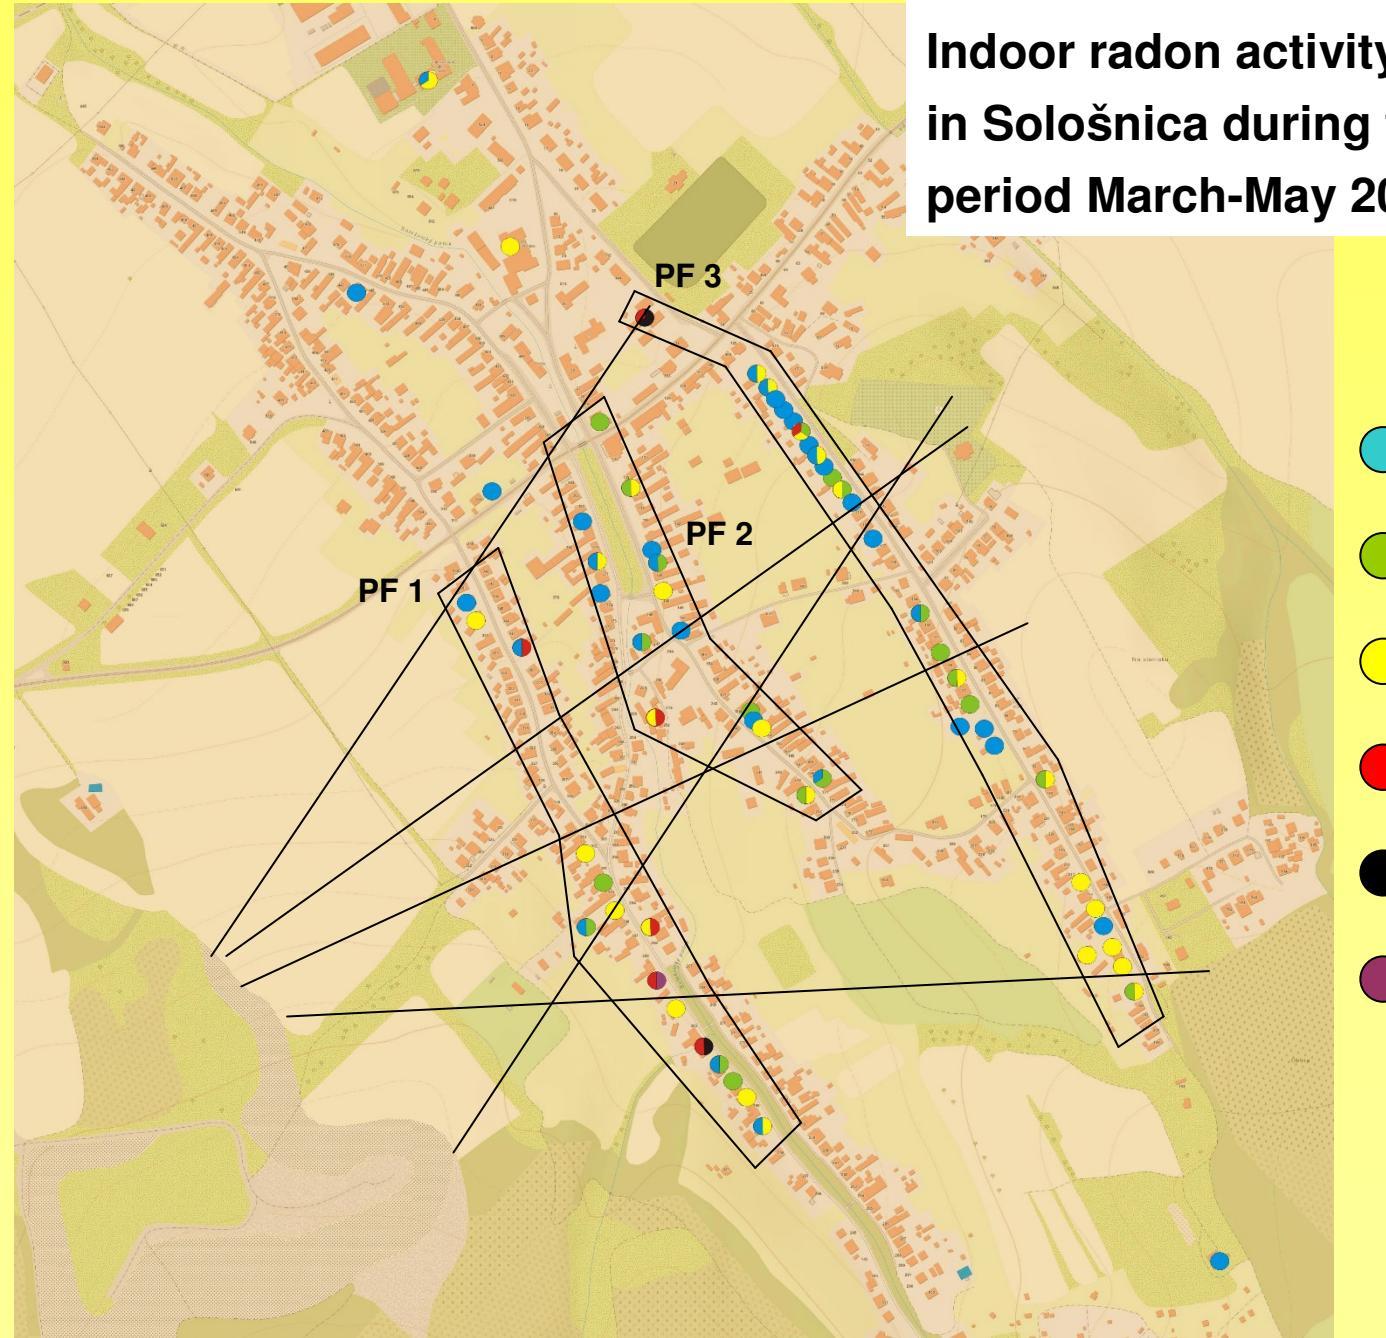
The comparison of indoor radon concentration

oldest buildings constructed in 19-th century and before year 1910: built mainly from local stone (travertine, limestone), brick and adobe - indoor radon < 200 Bq/m³

▶ 1940 - 1965: mainly brick, also stone, adobe, slag, aerated concrete. In the half of monitored rooms activity ranged 100-200 Bq/m³. The highest activities were found in rooms of a house made of bricks (250 Bq/m³ and 390 Bq/m³), in a direct contact with the subsoil, this house was thermally retrofitted.

▶ 1966 - 1980: mainly slag blocks or slag+bricks, several houses built from bricks and aerated concrete: activities > 200 Bq/m³ were found in rooms of houses made of slag, the highest activity measured in a house (415 Bq/m³), kindergarten

▶ 1981 - 1990: aerated concrete - low indoor radon. Among 27 monitored rooms, in 67% of them indoor radon was lover than the detection limit. Radon > 200 Bq/m³ was found only in a poorly ventilated room situated in a semi basement

▶ 1990 - 2000: indoor radon < 200 Bq/m³: new building materials available, the first legislation determining radioactive elements content limit in building materials was issued in 1992 in Slovakia

new buildings: aerated concrete, bricks, wood and slag blocks, indoor radon < 200 Bq/m³

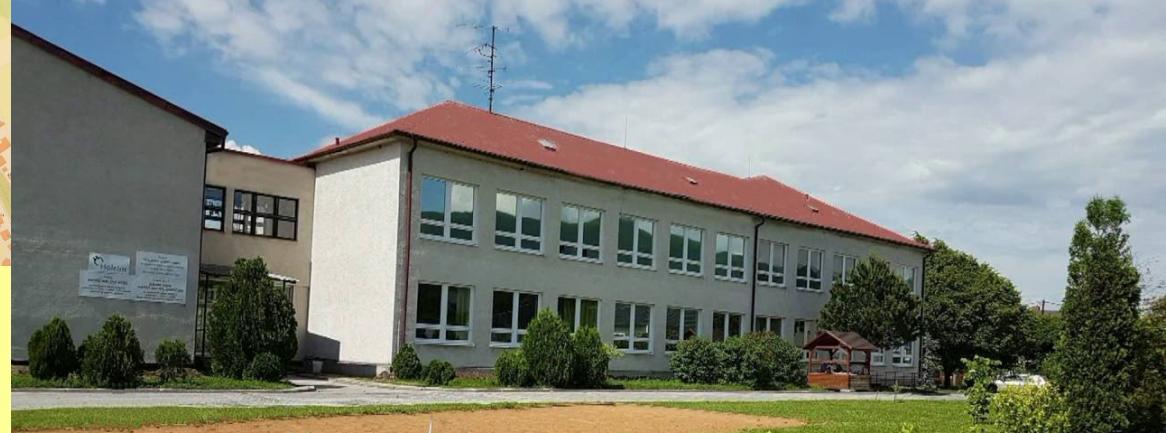
Primary school – three monitored classrooms on the groundfloor

- built in 1942 from brick
- reconstructed in 1992, another part of building was added, made of aerated concrete
- new windows, no thermal insulation
- two monitored classroom in old part (cellar/no cellar) and one in new part (no cellar) of the building
- low indoor radon (max 130 Bq/m³) (one detector was lost)

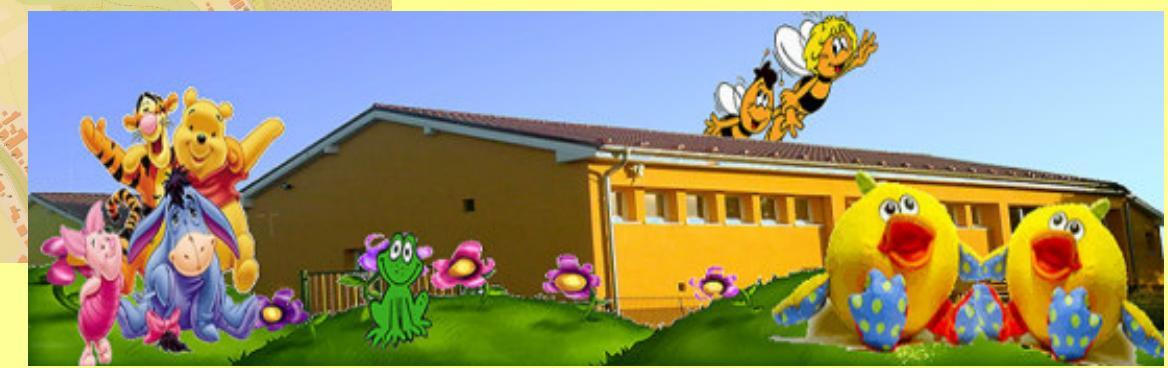
Kindergarten \rightarrow increased indoor radon activities in all 3 monitored classrooms

Frogs: 315 ± 55 Bq/m³

Butterflies: 365 ± 35 Bq/m³

Owls: 250 ± 50 Bq/m³

- single storey building
- made of brick, no cellar
- built in 1972 (79), reconstructed in 2008
- thermal insulation, new windows
- intensive ventilation according to the questionnaire
- teachers were recommended to increase the ventilation of classrooms
